Long Term Plastic Rubbish Study in Port Philip Bay

Ross Headifen Ph.D BeachPatrol Australia

Ramona Headifen MS. BeachPatrol Australia

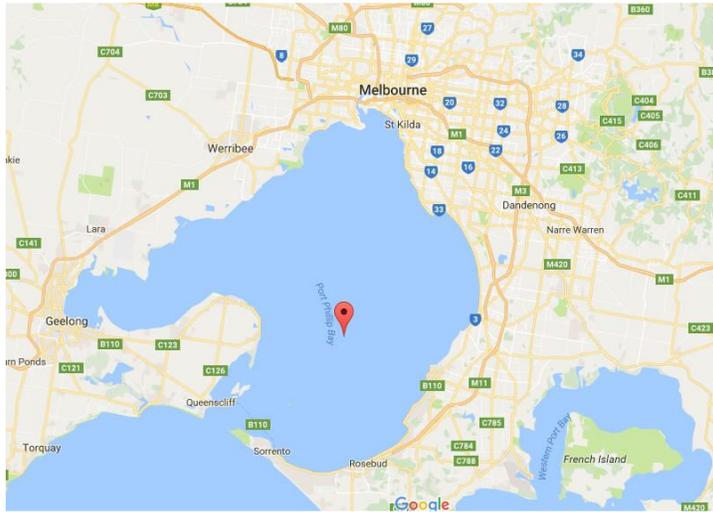
Figure 1, Port Phillip Bay

Background Port Phillip Bay is a large bay approx. 30 km across. It has narrow heads making the bay a near captive source of water. It has a coastal perimeter of 260 km. The city of Melbourne lies at the top. The bay is fed by a number of rivers, of which the Yarra river that runs through the city of

Melbourne is the largest. It enters at the Bay's northern most point. Studies by the State of Victoria's EPA⁴ show that very little in the way of debris that gets into the bay washes out through the heads to the ocean. Hence, what debris flows into the bay will either stay in the bay waters or wash out somewhere along the coast. The area is often windy and the wave action pushes most floating plastic rubbish ashore at some point.

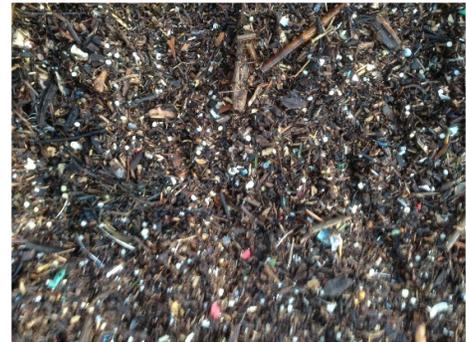
Figure 5 Microplastics

Microplastics are shown here to again show there is no obvious trend. While the trend line shows a decreasing slope, it is influenced by the 2017-2018 year. Year 5 has the same count as the first year which may be a better indicator. The microplastic counts in this survey were limited to obvious pieces of plastic to the naked eye and that could be picked up by hand. The actual amount of microplastics would be 1000's of times greater than this shown. There were many days where 100,000s of tiny blue, white and red flecks were on the sand at the water's edge or floating in the water ready to wash in. It was impractical to count these. The method used in reference 6 (*clean bay*) is a more detailed way to estimate microplastics.

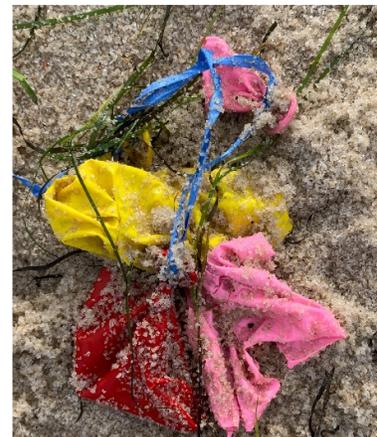
Figure 6 Balloons

This group includes balloons and balloon associated items such as the balloon sticks and clips.

This year shows again the year 2018-2018 was higher than any other year. Apart from that, the trend for the last three years would indicate an increase in balloon littering in spite of many anti balloon release campaigns^{10 zoo} or balloon release ban programs by local jurisdictions^{11 council}.

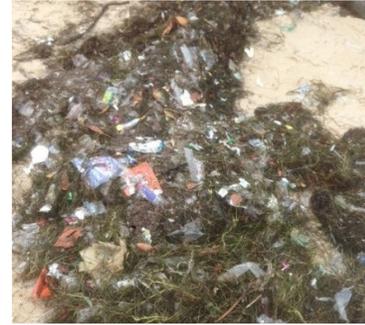
Figure 7 Food Wrappers

Food wrappers had the largest count in the specific category items. They made up 13.4% of all plastic picked up. After a period of high on shore winds, the seaweed washed ashore would have a high concentration of food wrappers and other pieces of plastic.

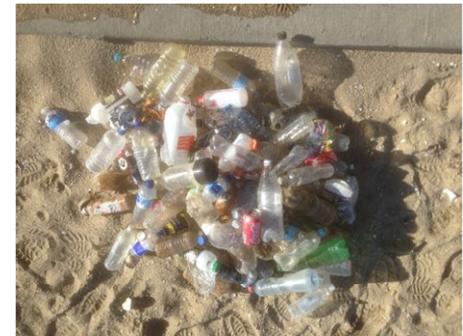
Figure 8 Drink Containers

Drink containers comprised glass bottles, plastic bottles and drink cans. There are some unusual factors for this category. Compared to the components that make up a complete bottle package such as bottles top and bottle labels, the count of containers was understandably low. For metal cans and glass bottle, they sink in water and do not wash in on a tide unless there is a large storm. Similarly plastic bottles are made of PET material, and this also has a specific density greater than water, so they too sink to the bottom. Only if the littered bottle has its top screwed on would it float and then wash ashore. Once ashore however, for plastic bottles as they are comparatively big, round with little weight, they easily blow up off the beach.

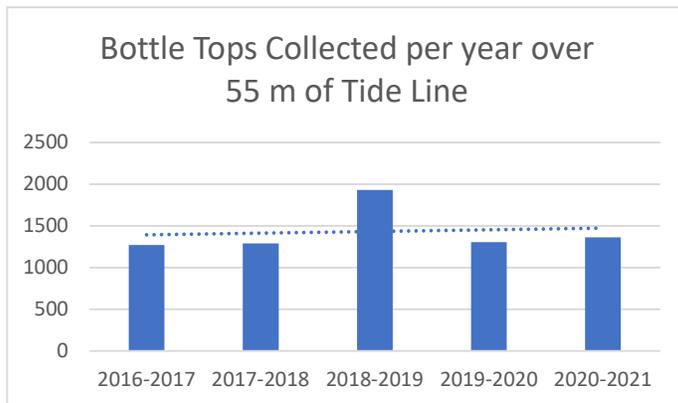
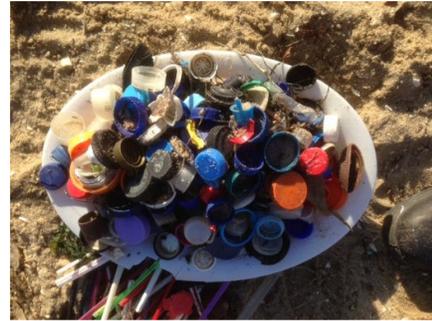
Figure 9 Bottle Tops

Almost 5 times as many plastic bottle tops were found per year as drink containers. Some days over 100 tops on the 55 m of tide line. The tops float and easily wash in with the tide. Their bright colour allows them to stand out against the sand background. A simple and low cost change to a tethered cap as trialled in a European study¹² would near eliminate this prolifically littered item on our beaches and other public spaces.

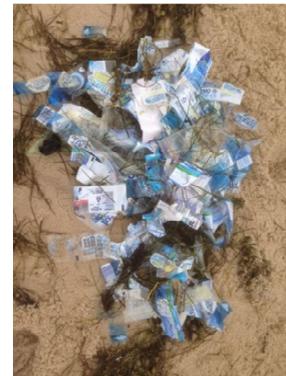
Figure 10 Drink Bottle Labels

These are plastic labels that come from plastic drink bottles. They are found in similar quantities to bottle tops. There are many problems associated with this one item. They are all caused by their design considerations being only for the bottle use and its sales and no provision for the littering situation. The labels are spot glued to the plastic bottle. Affixing one piece of plastic to another with a glue is a very technologically challenging and expensive problem to achieve a successful durable bond. The drinks industry with their very large output volumes, adopt a much lower cost and less robust method. Reputedly the labels are designed to come off when the bottles are recycled and put into wash tanks. However this means too that the labels readily come off when the bottle ends up in the ocean being agitated around with the waves.

The labels are also a composite label made of more than one layer of plastic. Layers for bonding, layers for strength and layers for printing on. Hence not only does the label come off a bottle in the

ocean, the layers separate as well, making multiple pieces of plastic litter. Their downward trend is skewed by a high number collected in the second year.

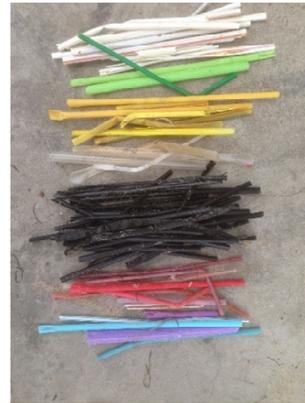
Figure 11 Plastic Straws

Plastic straws were one of the most prolific items collected. Many were attributable to fast food chains with their characteristic stripped patterns. In 2018 Buckingham palace banned straws¹³ in their royal estates. This caused a ripple effect around the world and many food service businesses followed suit over the next 24 months to phase out plastic straws. Figure 11 does show a declining trend line for straws being found on the beach. This trend line shows an approximate 9% reduction on average per year. Plastic straws are a simple item to replace as there are many substitutes to plastic straws available. This would help in their steady decline in usage. They are also one of the key items to banned in the Victoria State Plastic items ban in 2023⁷

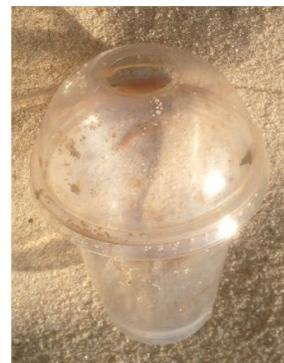
Figure 12 Cold Drink Cups and Components

These items were only separated out for the last three years. A slight declining trend is observable.

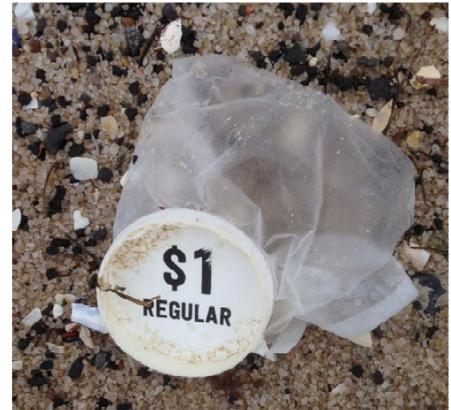
Figure 13 Coffee Cups and Lids

In many times, it is not obvious that a remnant piece of plastic is actually the remains of a disposable coffee cup. Sometimes it would just be a cloudy piece of plastic film. On some other times, the cardboard bottom would still partially be there to give away its identity. Hence it took some practice to more closely examine the plastic fragment to establish it was the remains of a coffee cup. These

items were only separated out for the last three years after gaining this experience. Perhaps the presence of Covid in 20-21 year exacerbated the use of disposable coffee cups.

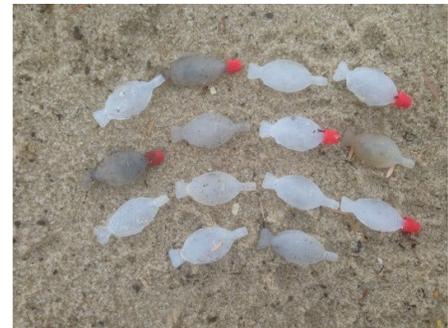
Figure 14 Food Containers

This group contained hard plastic take away food containers from take away shops, packaging for store brought food and sauce packets. It thus covered a range of hard plastic products. The trend was down until the last year which was the first covid 19 response year.

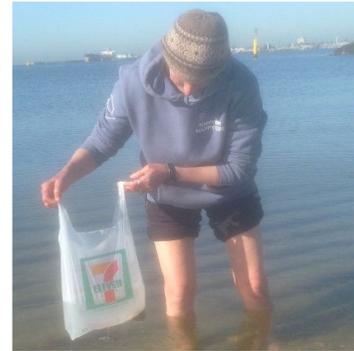
Figure 15 General Plastic Bags

This category included the store hand out tee shirt style bags and any other nonspecific bag. Plastic bags are a unique item for collecting from a beach. They are generally not lying on the sand like a piece of plastic film. Having a sealed bottom, they float at the water's surface and fill with water. They move through the water like an iceberg, with almost all of the bag just under the surface, hanging down 200-300 mm. As they approach the shoreline they run aground in shallow water of that same depth. There they fill with sand from the waves and settle to the bottom. Most plastic bags therefore are found in this shallow water partially filled with sand and buried. In the calm days are a storm with on shore winds, then that is when the plastic bag population is at its highest.

On 1 November 2019, the State of Victoria banned lightweight shopping plastic bags¹⁴. The consequence of this can be seen in figure 15 above. A steep decline in bags. It may be that the again sudden drop on in 2020 was due to people being outdoors a lot less due to Covid 19 restrictions for most of that year. The trend line shows a steep decline in plastic bags of 262 bags per year for this stretch of beach which is approximately a 25% decline per year from the 2016-2017 year supporting the concept of government ban regulations are very effective.

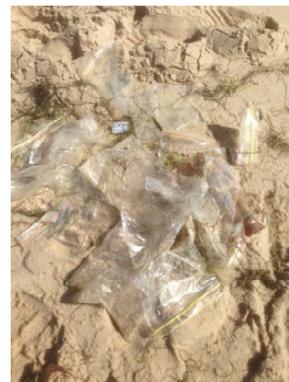
Figure 16 Zip Lock Bags

The high number of zip lock bags collected in the first year made it worth recording them thereafter. They are a significant portion of total plastic bags. Their frequency is trending up each year.

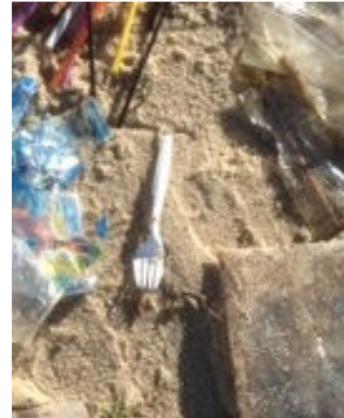
Figure 17 Cutlery

Plastic cutlery was not found in any significant quantities. Figure 17 shows typically only around 100 per year were picked up. Except for the 2018-2019 year, their quantity found per year did not change very much. This is one of the items listed to be banned under the State of Victoria ban in 2023⁷.

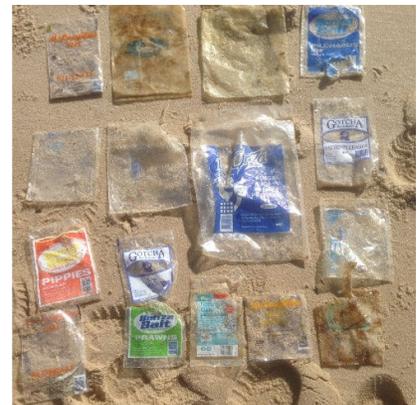
Figure 18 Fishing Gear

Fishing gear picked up was all most all bait bags. The steep increasing trend line shows the negative effect of a government plan to increase recreational fishing in Port Philip Bay¹⁵. More fishermen result in more littered bait bags. The drop off in 2020-2021 was attributable to the total fishing ban during the 2020 Covid-19 restrictions. The way bait is packaged and sold is not the best method for the application. They are a non resealable bag. This means once opened the fishermen cannot close them off again to take home. They could spill out and smell out their car. The contents are more likely to be dumped and this leads to a high amount of bait bags ending up in the water. If these bags were a resealable container, then possibly this could lead to less bait bag littering. Further research and consultation with the industry is needed.

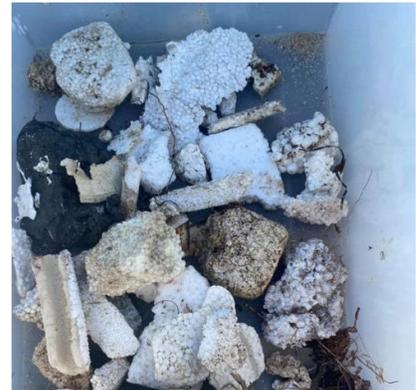
Figure 18 Polystyrene

Polystyrene includes chunks of polystyrene down to the individual little polystyrene balls 3-4 mm diameter that are liberated as the chunks break up. The above graph trend is a little skewed as in 2016 there was a storm that washed 1000's of polystyrene balls up on to the beach over just a few days. Otherwise the trend would show an increase.

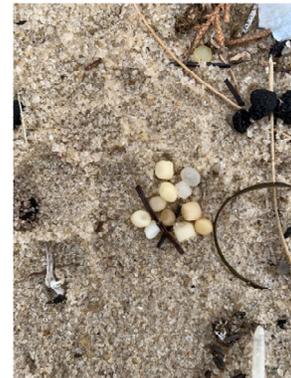
Figure 19 Nurdles

Nurdles are the little plastic beads made by the raw plastic manufacturers and sold to the plastic product manufacturers. Often called pre-production pellets. They are typically coloured cream, and 2-3 mm diameter with a cylindrical shape. If accidents happen during their transport or use, they get dumped in the 1000's, often washing down drains or waterways to get to the oceans. It takes an experienced eye to spot them as they can look like large grains of silica sand. The continuing rapid rise in plastic production will inevitably result in increasing spillage of nurdles unless some government regulation on their handling and use is introduced.

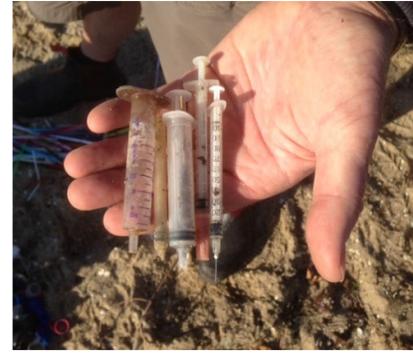
Figure 20 Syringes

Syringes are an unfortunate item found washed on to beaches. Measures to address their reduction would need to be quite different to the measures taken to address the other above common general consumer items. The trend line shows a slight increase per year.
